Subject:
Former Plainwell Impoundment and Plainwell No. 2 Dam Area Fall 2012 Bank Repair
Plan Technical Memorandum

GEORGIA-PACIFIC LLC
ALLIED PAPER, INC./PORTAGE CREEK/
KALAMAZOO RIVER SUPERFUND SITE
**FORMER PLAINWELL IMPOUNDMENT AND
PLAINWELL NO. 2 DAM 2012 BANK REPAIR**

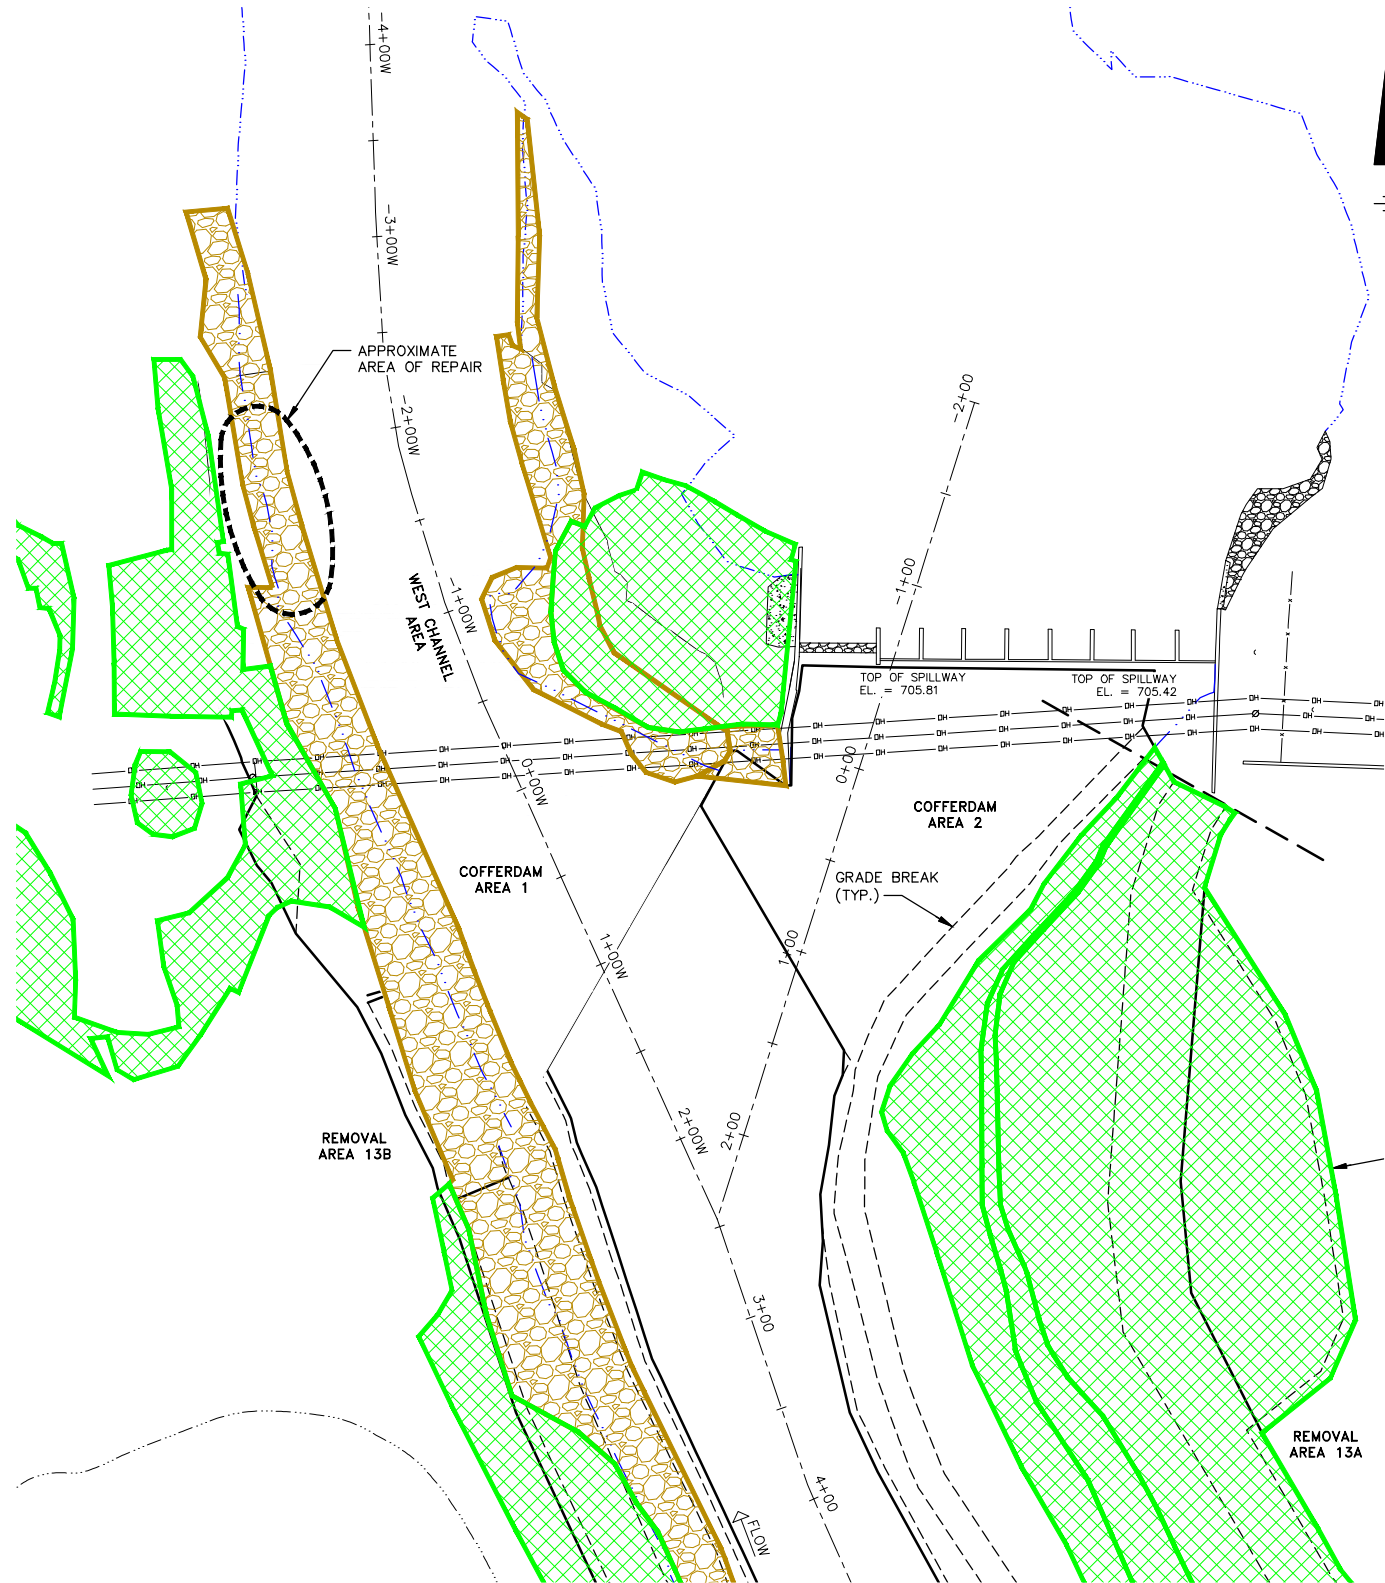
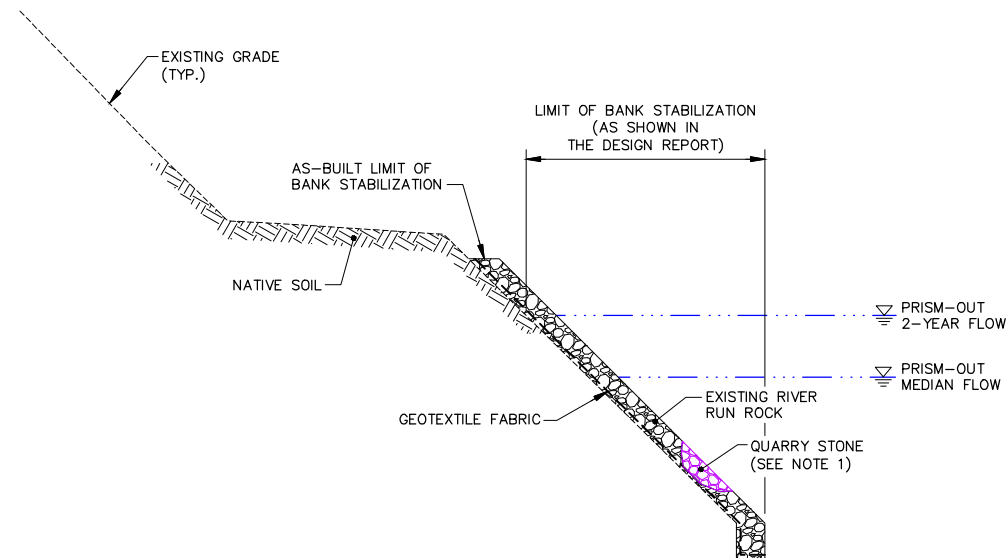
Figure 3 – Former Plainwell Impoundment Western Channel Proposed Bank Erosion Repair Plan and Cross-Section

During the August 30, 2012 and September 19, 2012 site walks, approximately 50 linear feet (ft) and 10 vertical ft of exposed geotextile fabric was observed on the south bank of the Western Channel downstream of the former Plainwell Dam (Figure 3). The geotextile was placed underneath the rock used for bank erosion protection as part of the TCRA. The exposed geotextile indicates that rock placed in this area has shifted towards the toe of slope, exposing the fabric, or that rock was not initially placed in this area since it was underwater at the time of construction and confirmation of placement of the intended amount and thickness of material over the complete extent of the area was difficult. This area is located immediately downstream of the Western Channel and is subject to the highest water velocities observed in the former Plainwell Impoundment.

According to the Former Plainwell Impoundment Design Report (ARCADIS BBL 2007), bank protection in the Western Channel was provided by a minimum 9-inch thick lift of rock with a mean diameter of 4 inches to the 2-year (prism-out) storm water elevation. The water elevation during a 2-year storm, based on the historical channel bottom elevation (prism-out), was selected as the upper limit of rock armoring for banks requiring armor (MDEQ 1998). This elevation occurs at a discharge of 3,845 cubic feet per second (cfs). The Hydraulic Modeling Letter concluded that flow conditions (i.e., channel bottom and wall shear stress and velocities) in the post-construction Western Channel are within the range predicted in the Former Plainwell Impoundment Design Report and, therefore, do not fall outside the design basis for the armor stone size. Rather, a known scour hole that formed during the September 2008 flood event when flow over the water control structure was influencing velocities in that area likely caused a small, local steepening of the bank angle that may have caused the rock to slide and expose the fabric. It is likely that the rock at this location settled after installation and exposed this small area of the geotextile fabric.

The exposed geotextile fabric will be covered with approximately 20 cubic yards (cy) of an angular rip rap placed from the top of bank. The rock will be 8-inch mean diameter angular stone with a maximum diameter of 18 inches. The plan view of the repair area and conceptual cross-section are shown on Figure 3. The bank slope is 3:1 and will not be altered by the repair.

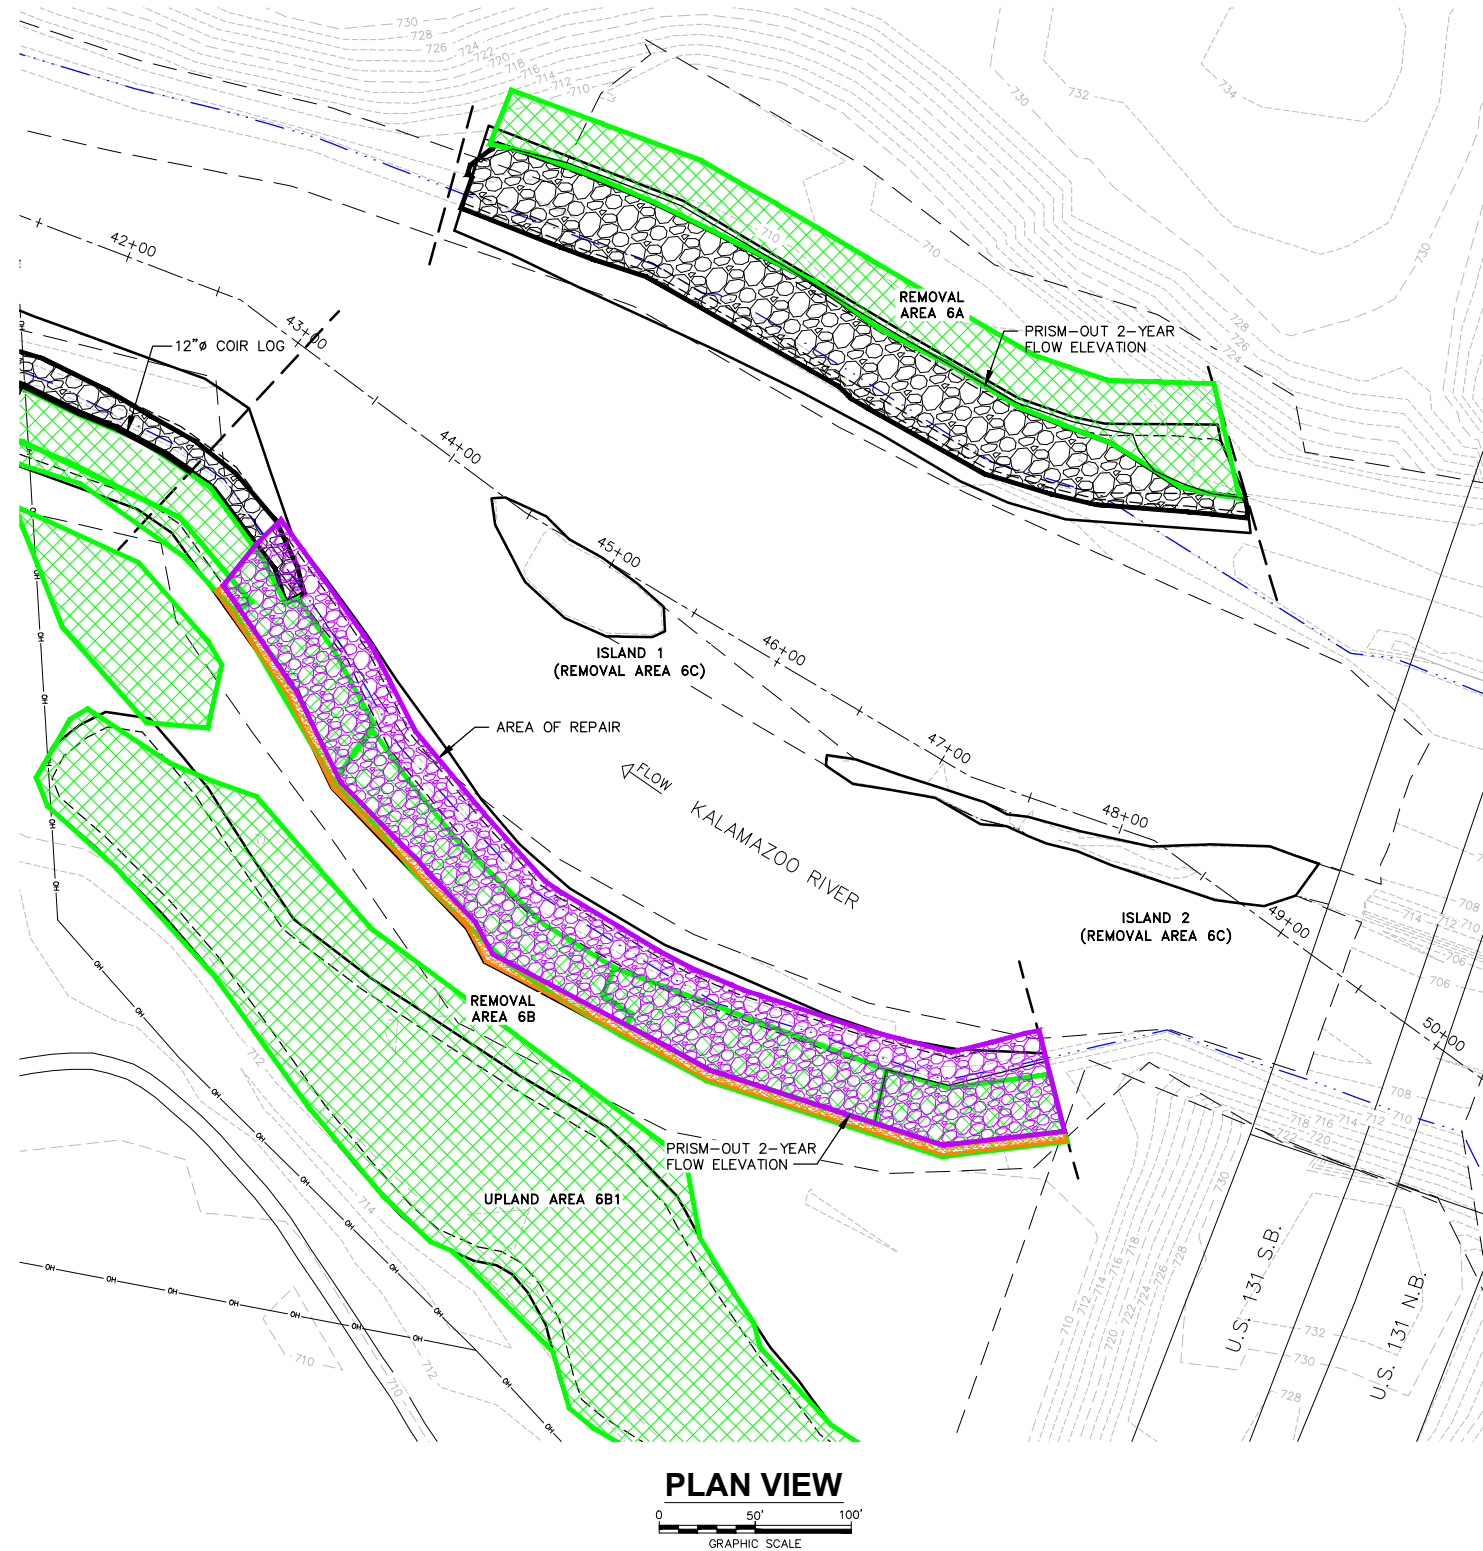
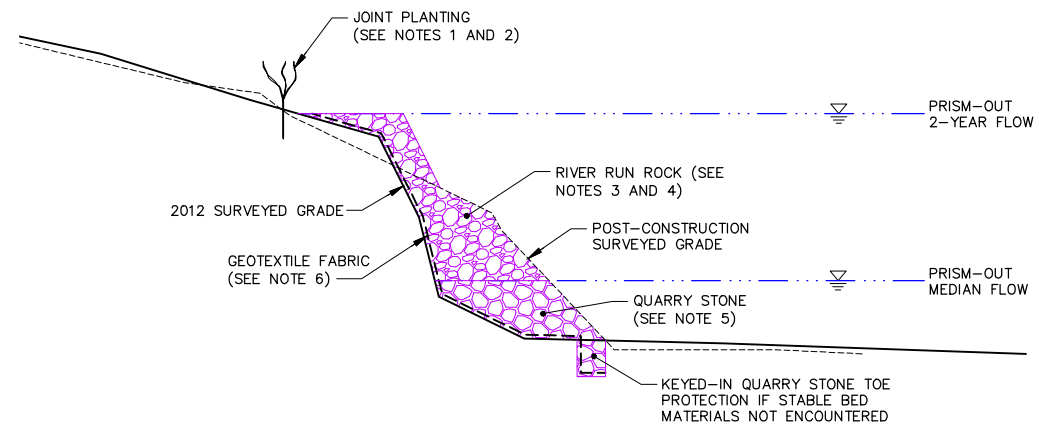
Figure 4 – Former Plainwell Impoundment Removal Area 6B Proposed Bank Erosion Repair Plan and Cross-Section

Approximately 500 ft of bank in Removal Area 6B (Figure 4) have been monitored since 2009 and have exhibited signs of continuing erosion. Removal Area 6B is located on the south bank, immediately downstream of the US-131 Bridge. According to the Former Plainwell Impoundment Design Report (ARCADIS BBL 2007), the area was not expected to be subject to erosional forces requiring rock-based armoring following material removal and revegetation activities. Recent site visits noted that the bank vegetation in this area is well established.

Channel flow is being directed toward the south bank at this location by a mid-channel bar that has established downstream of the bridge. Prior to the TCRA, two islands were present in the center of the Kalamazoo River, immediately downstream of the US-131 Bridge. Both islands were removed as a part of the TCRA. However, two new islands (gravel bars) have formed in the southern half of the channel downstream of the US-131 Bridge since completion of the TCRA. The new islands are not located in the same locations as the islands removed during the TCRA. The bridge and islands appear to divert water flow towards the banks in a manner that was not anticipated during TCRA design. The conditions causing erosion of the bank in Removal Area 6B do not appear likely to change in the near-term, so an increase in bank protection is needed. The primary objective of enhanced bank protection is to stop the erosion of the bank to maintain the remaining buffer between the river and bank material that was not excavated as a part of the TCRA.

Armoring the bank with stone was concluded to be the best option to address this eroding bank. Therefore, rock armoring will be installed in Removal Area 6B from the toe of slope to the prism-out 2-year storm water elevation (discharge of 3,845 cfs).

As recommended in MDEQ guidance (MDEQ 1998), a non-woven geotextile fabric (12,700 square feet [sf]) will be installed prior to rock placement to protect against erosion behind the rock. The rock will be mixture of an 8-inch mean diameter angular stone with a maximum diameter of 18 inches and a 6-inch mean diameter rounded stone with a maximum diameter of 12 inches. The local supply of the rounded stone used in the Former Plainwell Impoundment TCRA is limited. To the extent feasible based on available supply, the angular stone will be installed to the necessary thickness and elevation to create a stable slope below the prism-out median water elevation, and the rounded stone will be installed in a minimum 12-inch lift above the prism-out median water elevation to minimize aesthetic concerns. If a stable river bed is encountered at the toe of slope, the rock will be placed on the bed and graded to the prism-out 2-year storm water elevation. If a stable bed is not encountered at the toe of slope, the rock protection will be keyed in below the bed to a depth of approximately 1 ft to protect against bank undercutting.

Transect T-5S, surveyed as part of the 2012 BCMR (ARCADIS 2012a) is the only survey transect located in this area. Therefore the bank conditions at T-5S have been used for conceptual design, but bank geometry throughout the entire 500-ft bank repair area may vary. Approximately 1,000 cy of rock will be placed in the 500-ft repair area as shown on the plan view and cross-section included on Figure 4. The as-built geometry of the bank was a 3:1 slope. The bank repair will restore this geometry to the extent practical, and the final slope of the bank will be no steeper than 2:1. This volume estimate is based on one cross-section (T-5S in the 2012 BCMR) and is subject to change based on field conditions.

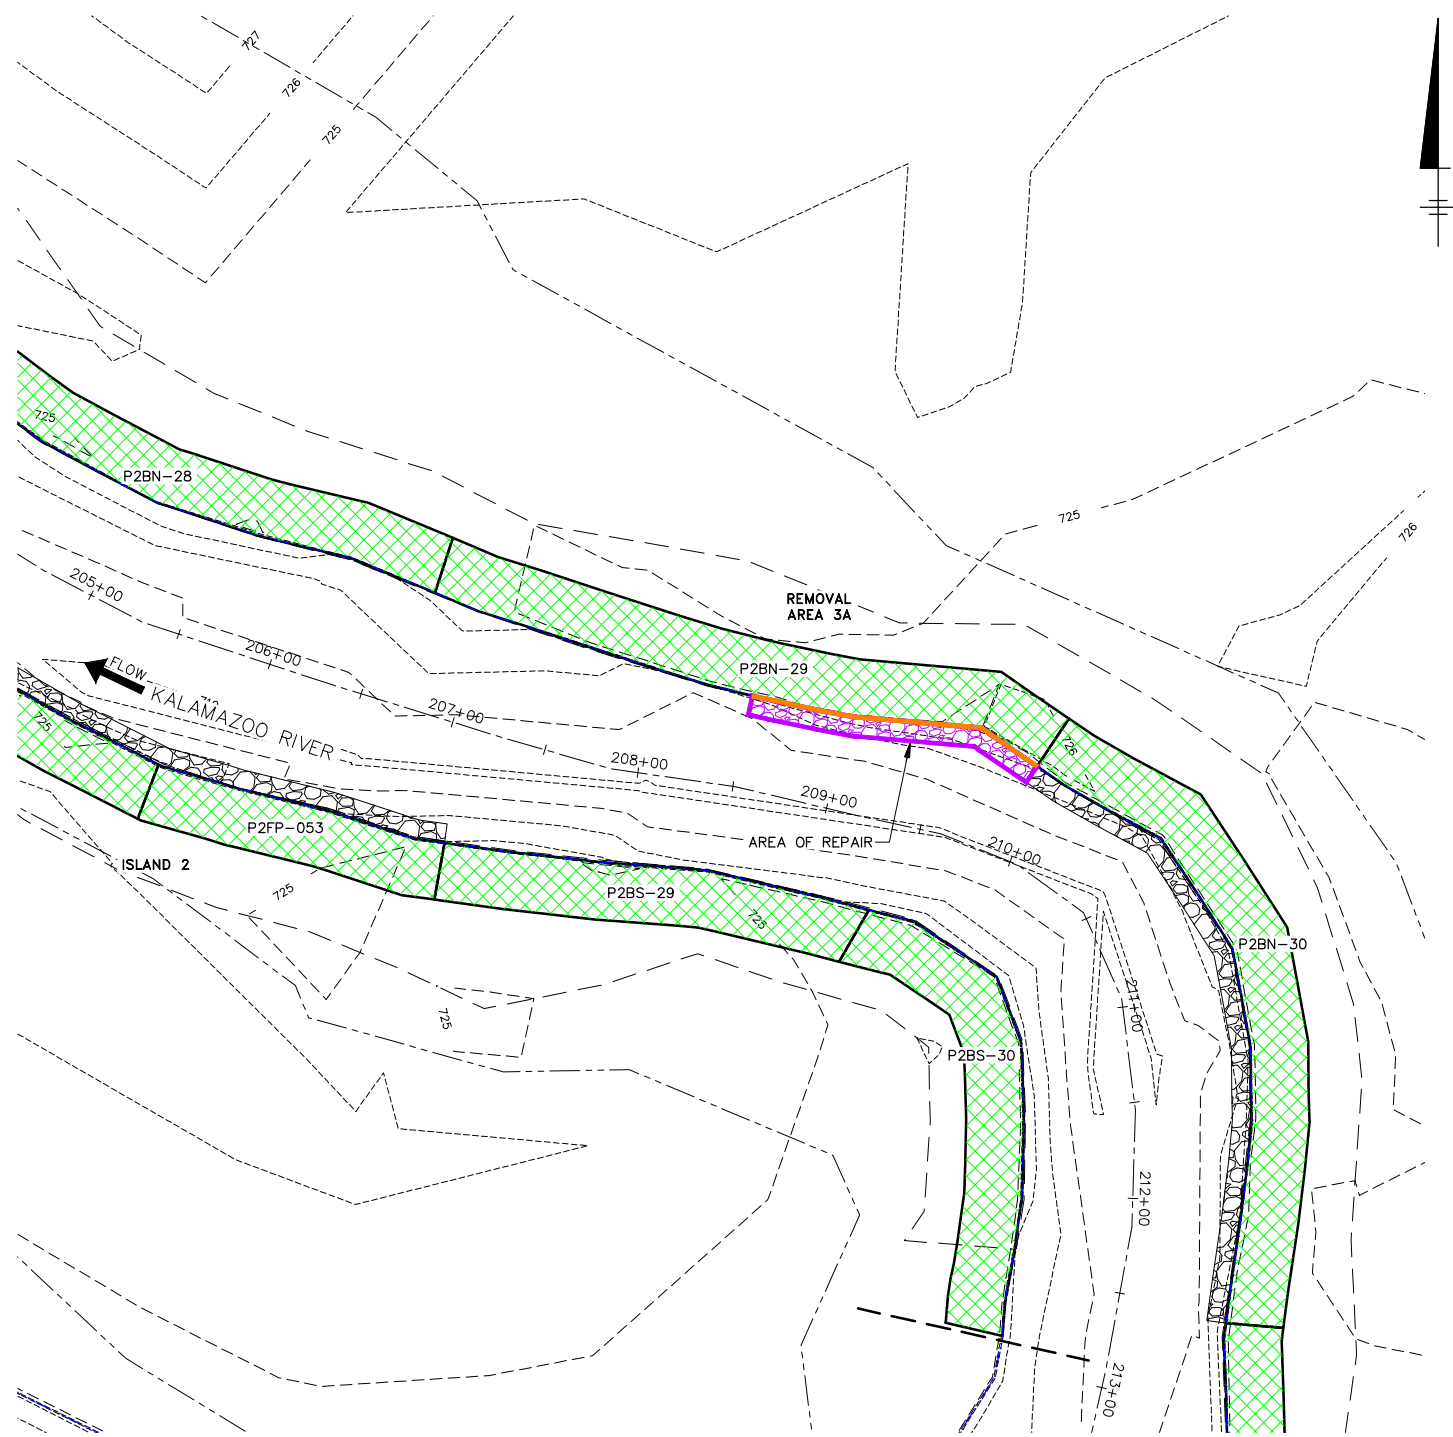
Figure 5 – Plainwell No. 2 Dam Removal Area 3A Proposed Bank Erosion Repair Plan and Cross-Section

As observed during the August 30, 2012 site walk, approximately 150 ft of bank in Removal Area 3A (Figure 5) is showing signs of having lost bank material and having developed an increased bank angle, which may jeopardize the stability of the bank, should any substantial further losses occur. Removal Area 3A is located at the downstream end of the outer (north) bank of a channel meander. Vegetation and root depth in this area decreased from 2011 to 2012, contributing to the increased potential for bank erosion. According to the Plainwell No. 2 Dam Area Design Report (ARCADIS 2009), this area was not expected to be subject to erosional forces requiring rock armoring following removal and revegetation activities.

The observed erosion is related to hydraulic forces on the banks that necessitate armoring. Rock toe protection was installed immediately upstream of the observed erosion. Prior to material removal, the bank naturally cut north, away from the main flow of the river at the point of erosion. The existing rock toe protection immediately upstream deflects the water velocity into the downstream bank where the erosion was observed. The conditions causing erosion of the bank in Removal Area 3A are not likely to change in the near-term, so enhanced protection of the bank is needed. The primary objective of increased bank protection is to stop the erosion of the bank to maintain the remaining buffer between the river and bank material that was not excavated as a part of the TCRA.

The rock toe protection installed upstream of this bank repair location will be extended approximately 150 ft downstream to form a smooth, consistent toe of slope on the outside of the meander. Toe protection will extend from the toe of the restored bank to the median flow elevation, as modeled in the Plainwell No. 2 Dam Area Design Report (ARCADIS 2009). This elevation occurs at a discharge of 950 cfs. Rock toe protection to this elevation will usually be underwater and not visible except during drought conditions and would allow bank access by semi-aquatic wildlife species that forage along the bank. In addition, a coir log will be installed at the interface of the top of the toe protection at the median water elevation. The coir log will provide additional energy dissipation and erosion protection at the waterline until bank vegetation establishes enough to provide long-term bank stability. The coir log will be 9 to 12 inches in diameter and secured with stakes and twine lashing as necessary to adequately secure the coir log. A well stabilized toe will prevent general widening of the channel, although some slope adjustment to the bank between the median water level and the top of bank may occur.

As recommended in MDEQ guidance (MDEQ 1998), a non-woven geotextile fabric (2,000 sf) will be installed prior to rock placement to protect against erosion behind the rock. The rock will be mixture of an 8-inch mean diameter angular stone with a maximum diameter of 18 inches and a 6-inch mean diameter rounded stone with a maximum diameter of 12 inches. The local supply of the rounded stone used in the Plainwell No. 2 Dam Area TCRA is limited. To the extent feasible based on available supply, the angular stone will be installed to the necessary thickness to create a stable slope below the median water elevation, and the rounded stone will be installed in a minimum 12-inch lift near the median water elevation to minimize aesthetic concerns. If a stable river bed is encountered at the toe of slope, the rock will be placed on the bed and graded to the median flow elevation. If a stable bed is not encountered at the toe of slope, the rock protection will be keyed in below the bed to a depth of 1 ft to protect against bank undercutting.

Transect T-4, surveyed as of the 2012 BCMR (ARCADIS 2012a), is the only survey transect in this area. Therefore, the bank conditions at T-4 have been used for conceptual design, but bank geometry throughout the entire 150-ft bank repair area may vary. The as-built geometry of the bank was a 3:1 slope. The bank repair will restore this geometry to the extent practical, and the final slope of the bank will be no steeper than 2:1. Approximately 100 cy of rock will be placed in the 150-ft repair area as shown on the

plan view and cross-section included on Figure 5. This volume estimate is based on one cross-section (T-4 in the 2012 BCMR) and is subject to change based on field conditions.
